## AERIAL PHOTOGRAPHIC ANALYSIS OF EIGHT HAZARDOUS WASTE SITES

Indiana

PARROTT ROAD DUMP

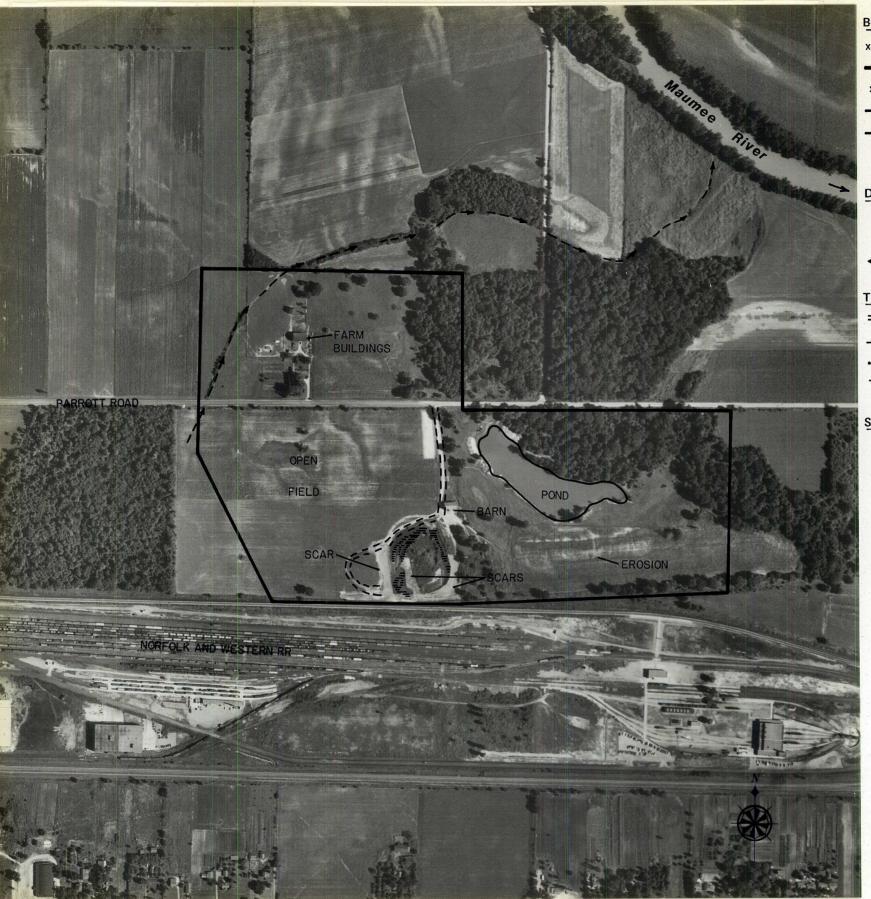
Figure 22 shows the future location of the Parrott Road Dump. The area is largely agricultural with several farm buildings, a large barn, and open fields. An elongate pond is located in the southeast portion of the site and an area of erosion is noted immediately south of it.

Although no solid waste materials are seen at the site some ground scars and water-filled depressions are observed just south of the barn.

Figure 22. Parrott Road Dump, August 10, 1951. Approximate scale 1:6,000.

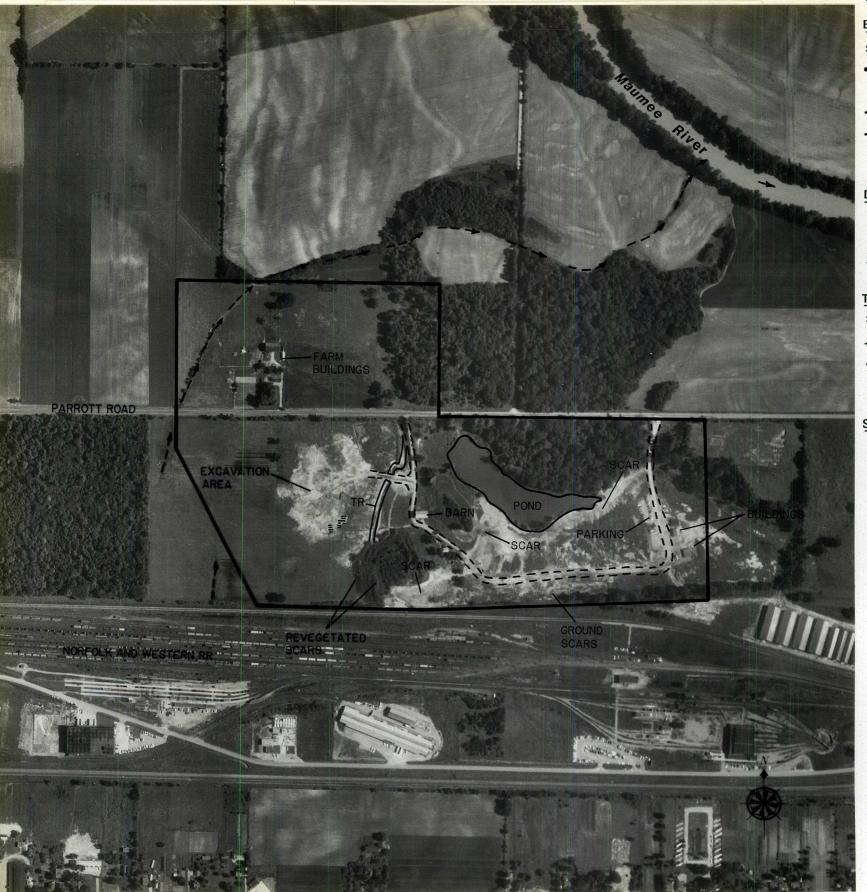
By 1957 (Figure 23) there is evidence of excavation and trenching activity, but not of waste disposal, in the southern portion of the site. A group of new buildings with adjacent parking, occupies the eastern edge of this area. Numerous ground scars are noted near the pond and along a new access road which runs through the site.

Most of the scarred area seen in 1951 (Figure 22) just south of the barn has been revegetated and the water-filled depressions are no longer visible.

Figure 23. Parrott Road Dump, June 20, 1957. Approximate scale 1:6,000.

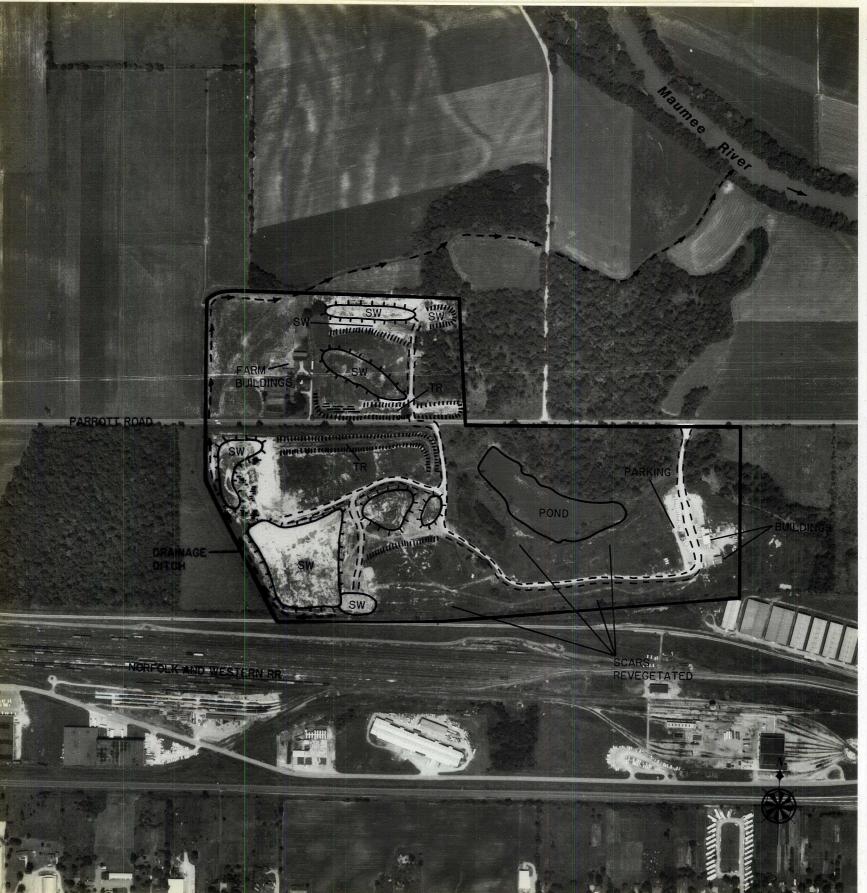
Figure 24 shows that solid waste disposal now dominates the western half of the site. In the northern portion of the site, just to the east of the farm buildings, several areas of solid wastes are divided by dikes. Also, two trenches now parallel both sides of Parrott Road. In the southern portion of the disposal area, there are three areas of solid waste and two locations of mounded material which may also contain solid wastes. Standing liquid in small pools, noted near a solid waste pile, may contain seepage.

In the eastern half of the site the widespread scars seen in 1957 are now revegetated.

Figure 24. Parrott Road Dump, July 5, 1964. Approximate scale 1:6,000.

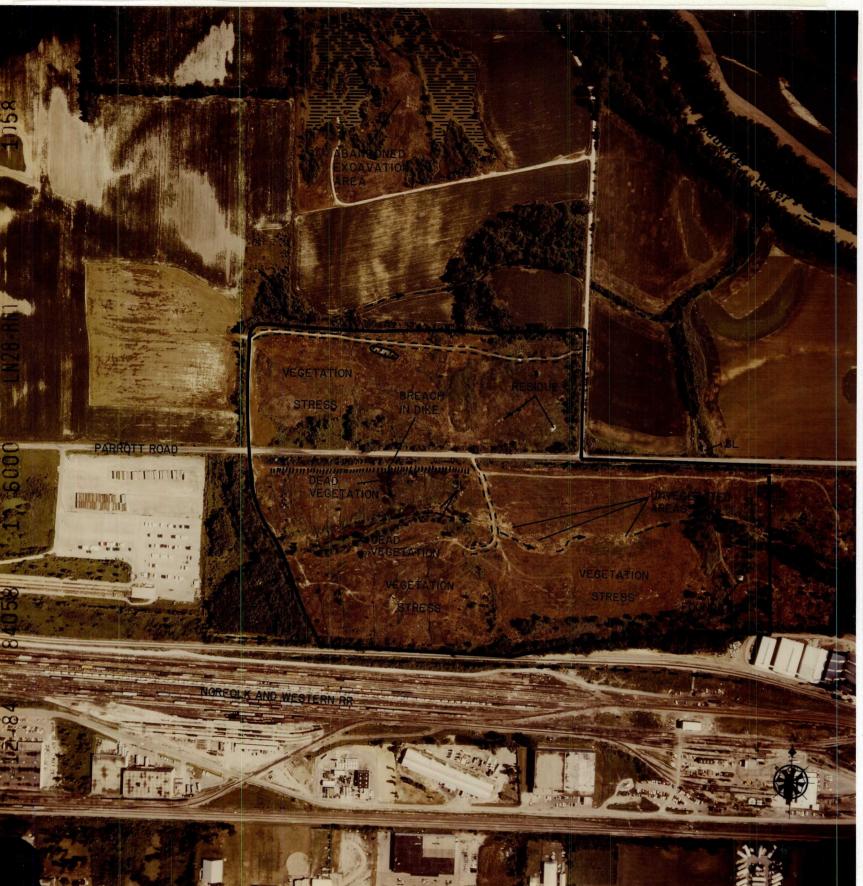
Figures 26 and 27 show the current condition of the dump site. All areas contain stressed vegetation which is stunted and discolored by comparison to the surrounding areas. The buildings and parking area previously located in the southeastern portion of the site have been removed with only one foundation remaining.

The southern half of the site is now bisected by an east-west trending drainage channel. Dead vegetation and unvegetated areas follow the trend of this channel. Four areas of standing liquid (possibly containing seepage) are seen along this channel. Dead vegetation is also noted along a short drainage path emanating from a breach in the dike which parallels Parrott Road.

In the northern portion of the site, a new road has been established along the northern site boundary. A shallow pit and two areas of white residue are also observed. Just outside the site boundary, two areas of standing liquid are seen which may contain seepage.

Figure 26. Parrott Road Dump, July 12, 1984. Approximate scale 1:6,000.

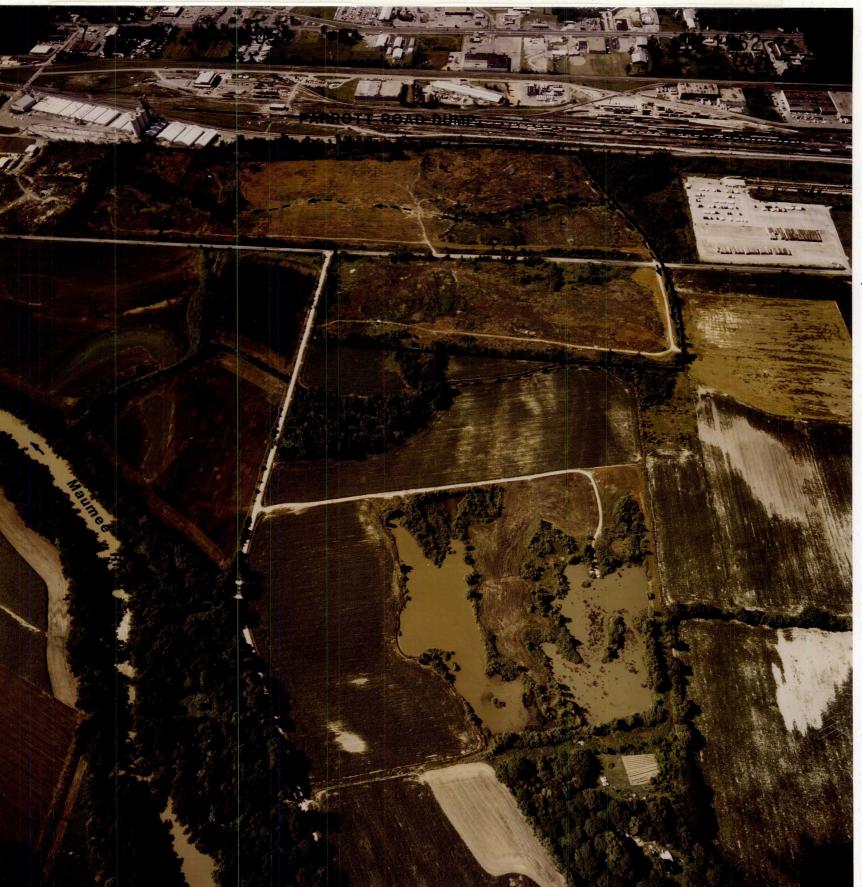
Figure 27. Parrott Road Dump, July 12, 1984. Oblique looking south.
